K-195 Thornton Chestertown Private

Thornton is a fine late 18th century plantation house of brick. The main house is five bays wide with two rooms per floor and a central hall. The kitchen wing also brick is covered with a catslide roof. The house retains an unusual amount of original trim and detailing, including a fine later porch. The interior is a treasure of original woodwork and painted graining. This decoration is now valuable and rare; having passed from favor in the 20th century, much of it was painted over and damaged. It has survived at Thornton, however, and in almost perfect condition. The house was built by the Brooks family, by whom it is still owned.

INVENTORY FORM FOR STATE HISTORIC SITES SURVEY

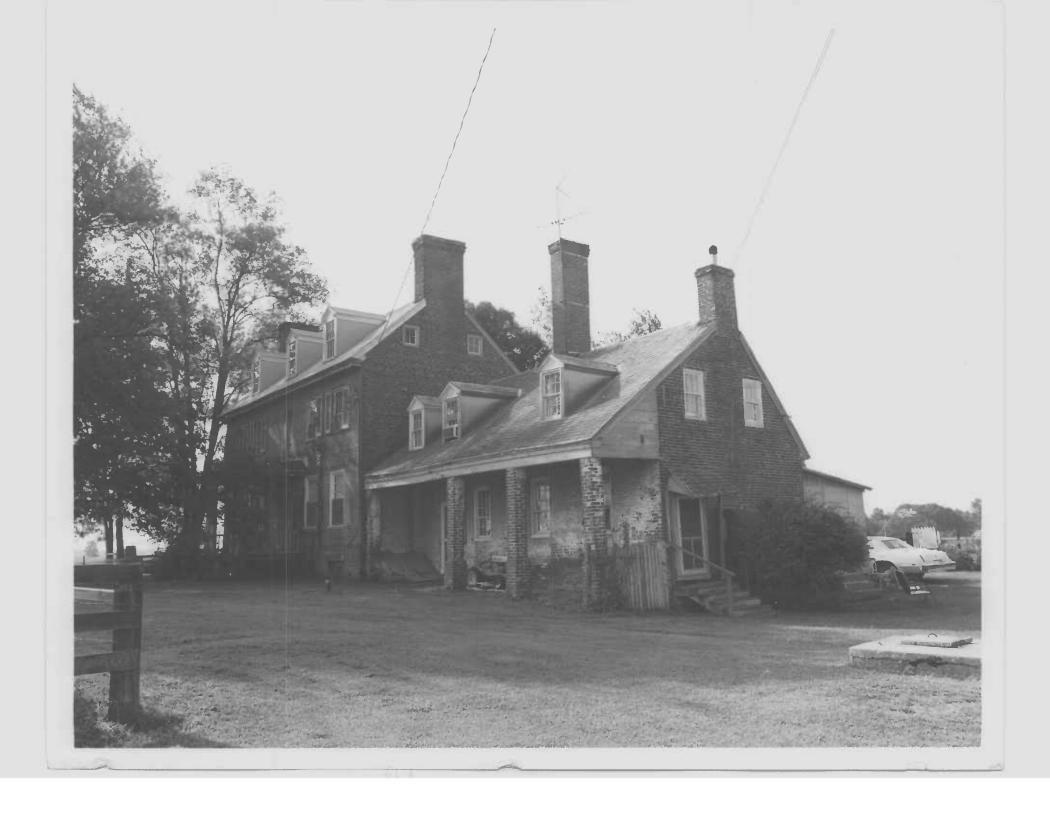
THORNTON MHT 195

FRONT - NORTH WEST

The brick of the main house is laid in Flemish bond on the north (approach) facade, Liverpool bond on gables and rear, and English bond below the water table (which is found on the front, rear facades and on the east gable.)

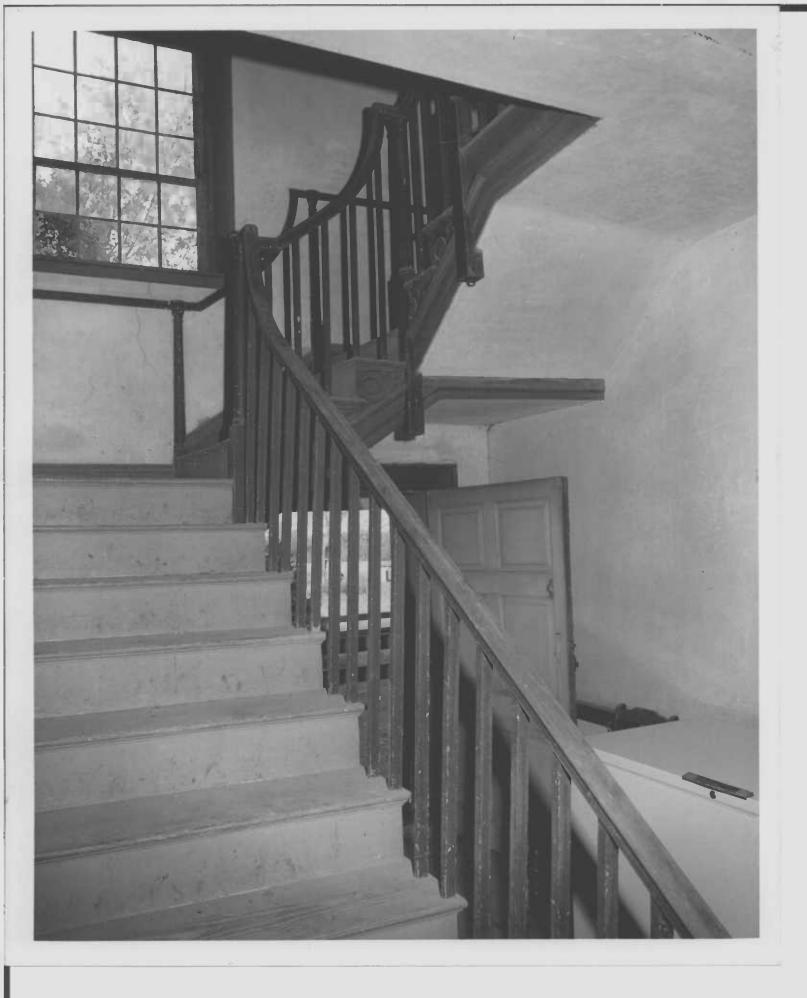
THORNTON MHT 195
PERKINS HILL RD
CHESTERTOWN, MD.

HIGHER SECTION - STAIRWAY

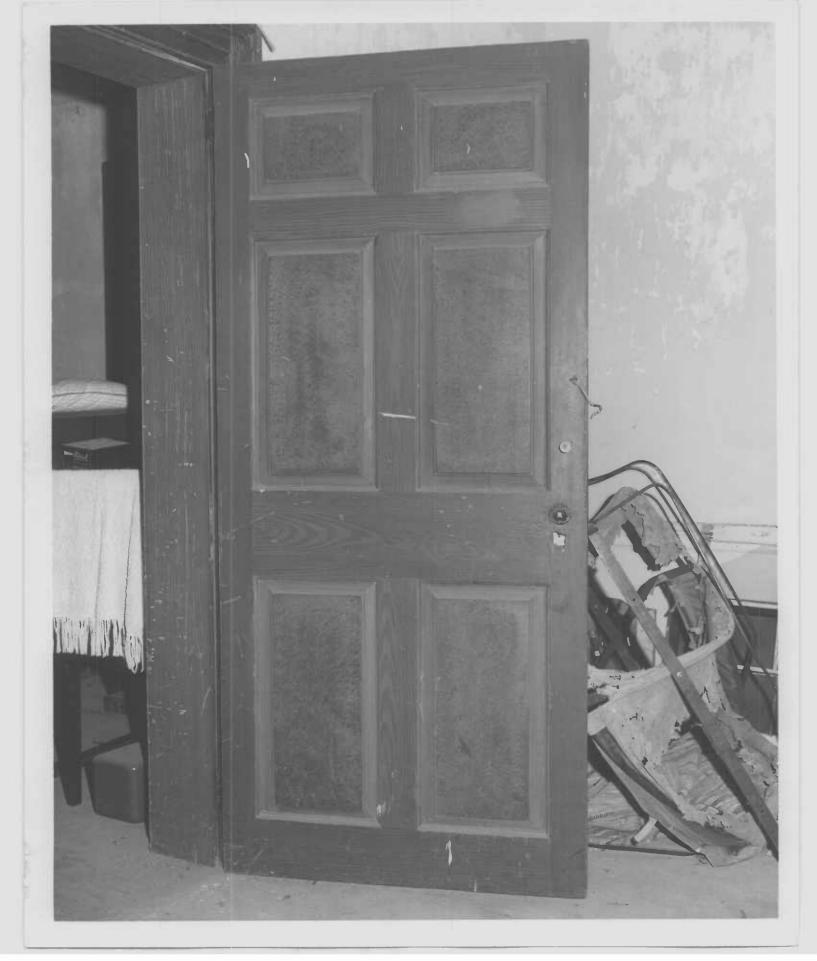
Thanton M.H.T.195 Terkins Hill Rd. Chectertoever, Md.

First Hoss- Fall Section. Frained Loor at entrance to South Room C. Ting strone aug 1977

Thornton retains an unusual amount of original trim and detailing on the exterior, but the interior is a treasure of early woodwork and decoration. Virtually all major features remain in place and most are decorated with painted graining. This decoration is extremely valuable and rare; having passed from favor in the 20th century, much of it was painted over and damaged. It has survived at Thornton, however, and in almost-perfect condition. The date of the graining is impossible to determine without paint analysis by an expert, however, the molding profiles are very sharp and in a damaged door in the parlor chamber only one color of paint, a bright, light blue, was visible, both of which would indicate that this was an early treatment, probably before
